# **BASIN MANAGEMENT ACTION PLAN**

**for the Implementation of Total Daily Maximum Loads for Fecal Coliform Adopted by the Florida Department of Environmental Protection**

## **Lower St. Johns River Basin Tributaries**

**December 2009**

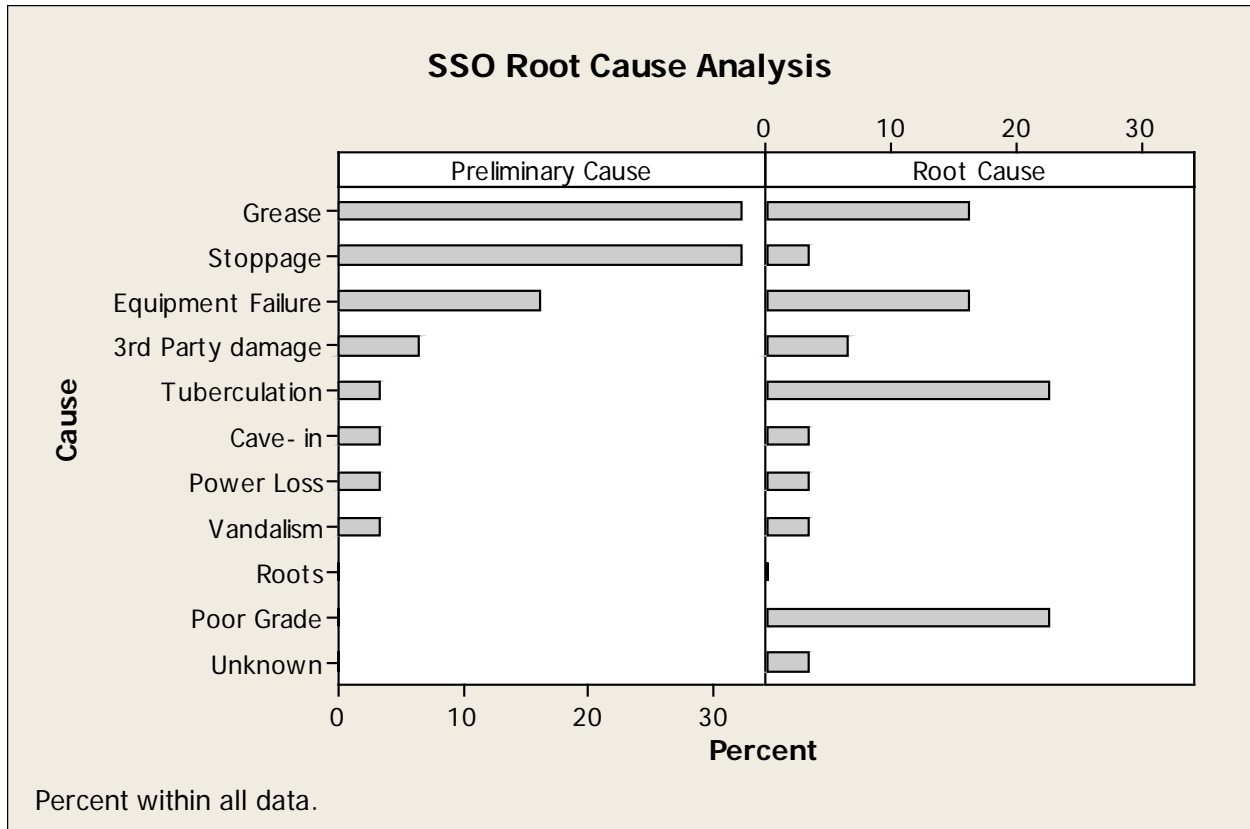
FIGURE E-1. SSO ROOT CAUSE ANALYSIS

The SSO Root Cause Program began in January 2007 and is run by a group of first responders, who meet every two weeks to determine the root cause of each SSO so that an effective solution can be implemented. The Root Cause Committee identifies the root cause and determines short- and long-term corrective action to prevent reoccurrence. It also identifies any improvements that can be made to reporting procedures. As indicated in the following table, the Root Cause Program has revealed that in many cases, the identified preliminary cause is not the true root cause of the overflow.

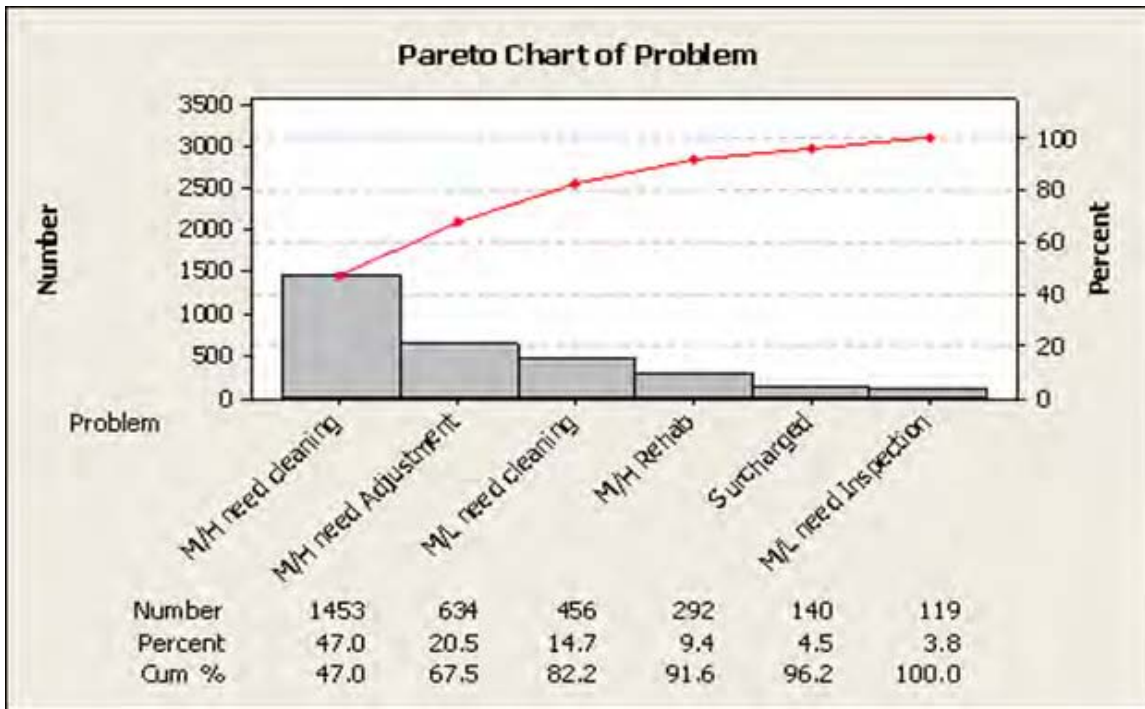
FIGURE E-2. PROBLEMS IDENTIFIED THROUGH THE POP-TOP PROGRAM

JEA implemented the Pop-Top Program in early 2007 to open and inspect all accessible manholes in the service territory (approximately 54,000 manholes), with the objective of preventing future SSOs. Since April 2007, JEA crews have inspected more than 30,000 manholes to detect potential problems in the collection system. Generally, the problems of greatest concern are manifested through surcharged conditions (backups of flow to varying degrees) that typically result from a restriction in flow downstream of the surcharged manhole. In some cases, the discovery of a surcharged condition has resulted in an immediate response to prevent a potential SSO. In many more cases, the pop-top inspections have identified conditions that, if unresolved, could result in an SSO sometime in the future. These lines are placed on a cleaning schedule to avoid the possibility of an eventual SSO. **Figure E-2** shows the problems identified in manholes (M/H) and main lines (M/L) to date as the result of the pop-top inspections, including 140 instances of surcharged lines.

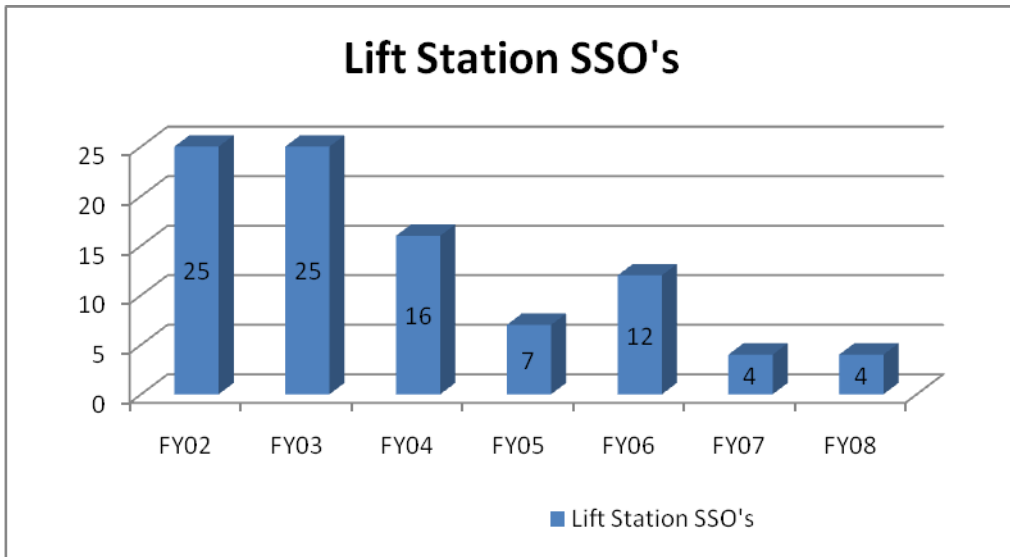
FIGURE E-3. LIFT STATION SSOs, FY02–FY08

The SCADA Program was implemented at JEA lift stations. Alarms sound if the sewer in a wet well rises above a specific level, and triggers an alert to the JEA lift station Operations and Maintenance Group. They respond immediately to avoid an SSO. Currently, 1,230 lift stations have been retrofitted with SCADA telemetry systems at a cost of more than \$22 million. With SCADA, JEA can respond to a comprehensive list of alarms, including high wet-well levels, power outages, and pump failures. During a typical week, there are between 40 and 50 wet-well high alarms received from the 1,230 stations on SCADA.

The implementation of SCADA monitoring at JEA’s lift stations has resulted in a significant decrease in lift station-related SSOs, as shown in **Figure E-3**.

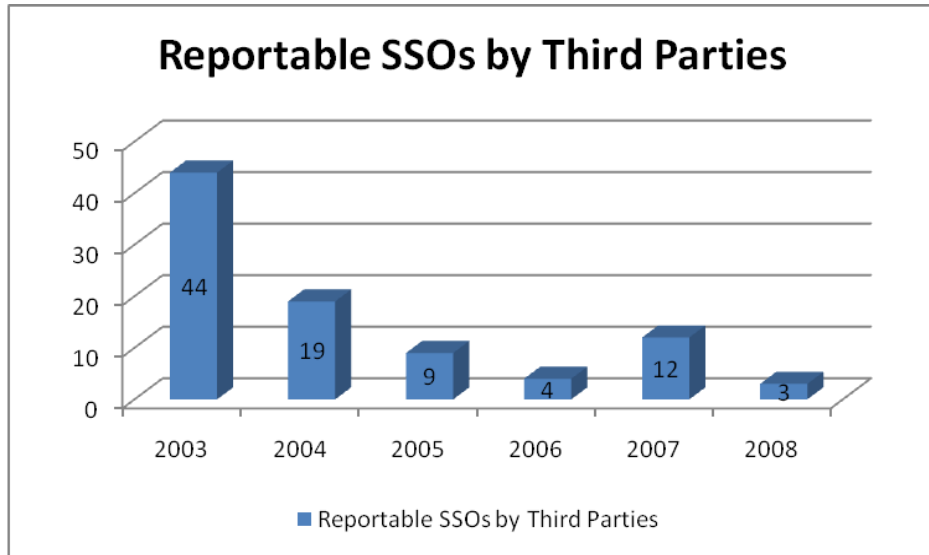
FIGURE E-4. REPORTABLE SSOs BY THIRD PARTIES, 2003–08

In 2003, JEA implemented a program to address SSOs caused by third-party contractors. The program involves an increased emphasis on both education and enforcement of the contractors who routinely perform excavations in the vicinity of JEA infrastructure. The program has been successful in dramatically reducing the SSOs caused by third-party hits on JEA sewage lines, as shown in **Figure E-4**.
